Historic Structure Report
Main House and Annex
Scotty's Castle, Death Valley Ranch

HISTORIC STRUCTURE REPORT
DEATH VALLEY SCOTTY HISTORIC DISTRICT
MAIN HOUSE AND ANNEX

September 1991

UNITED STATES DEPARTMENT OF THE INTERIOR / NATIONAL PARK SERVICE

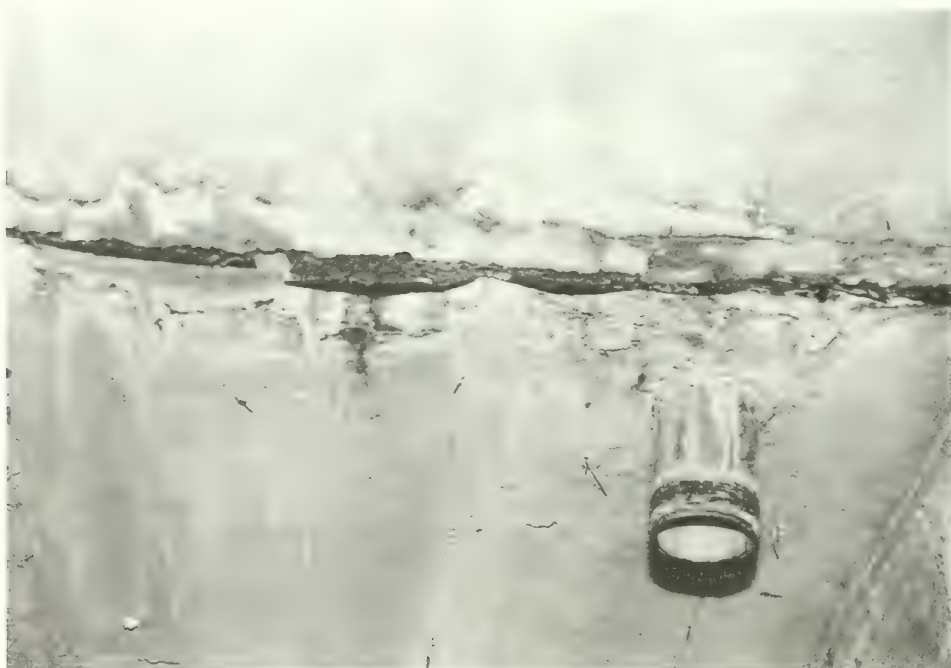
Photo 2: Underside of tunnel roof slab. Shows deteriorated joint filler and concrete as well as a typical uncompleted deck drain. (Photo by R. Silva)

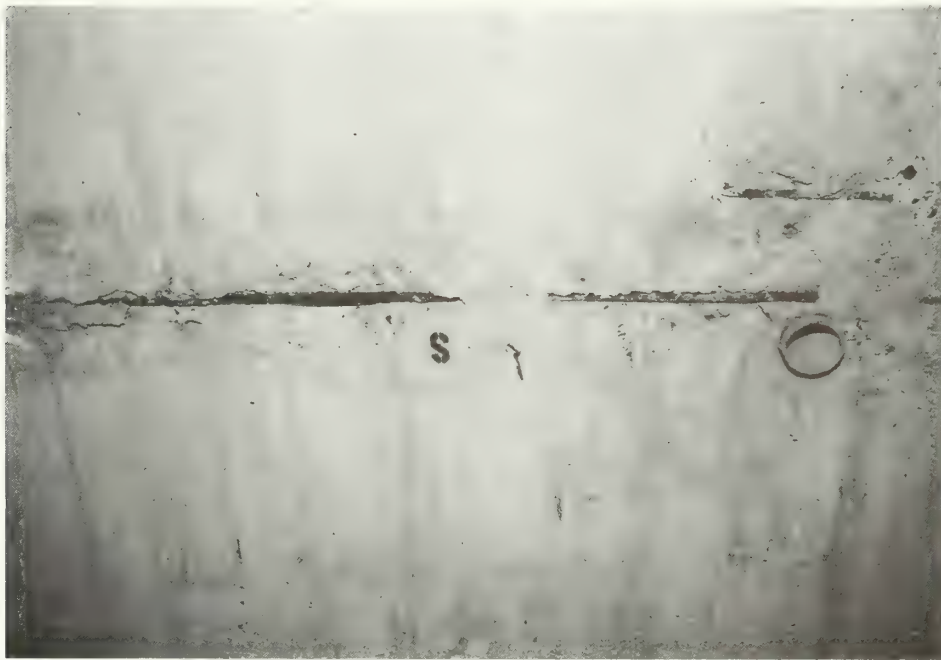
Photo 3: Underside of tunnel roof slab at location "S." Shows concrete spalling caused by rusted reinforcing bar. Another deck drain stub is also visible. (Photo by R. Silva)

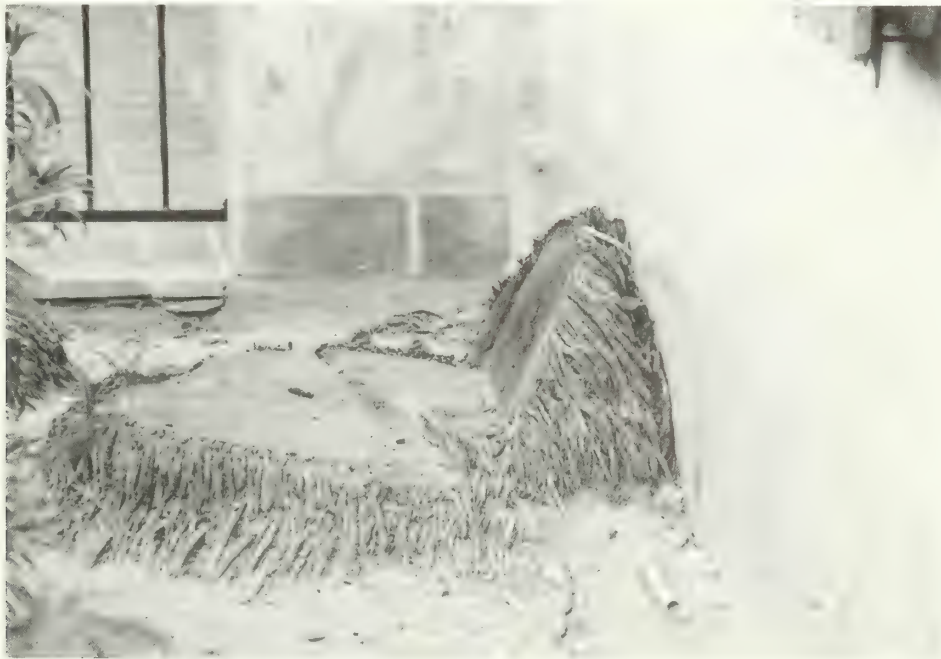
Photo 4: Trees against foundation walls. Caused damage in the past, particularly in the tunnel wall near the southeast corner of the Main House. Trees have been removed, such as these in front of the Main House. (Photo by R. Silva.)

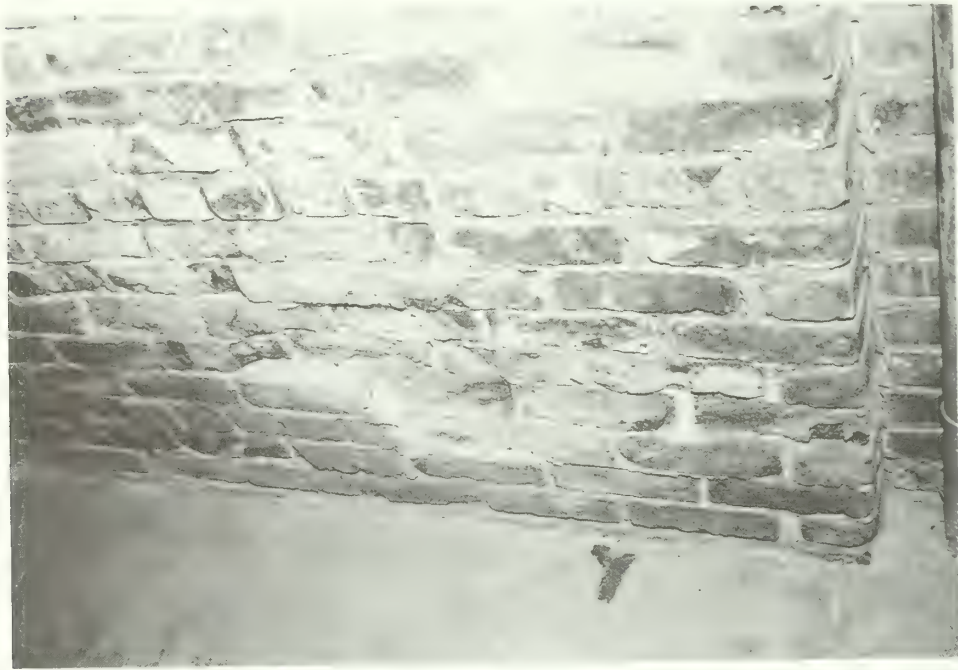
Photo 5: Deteriorated brick at foundation of Great Hall fountain. (Photo by R. Silva)

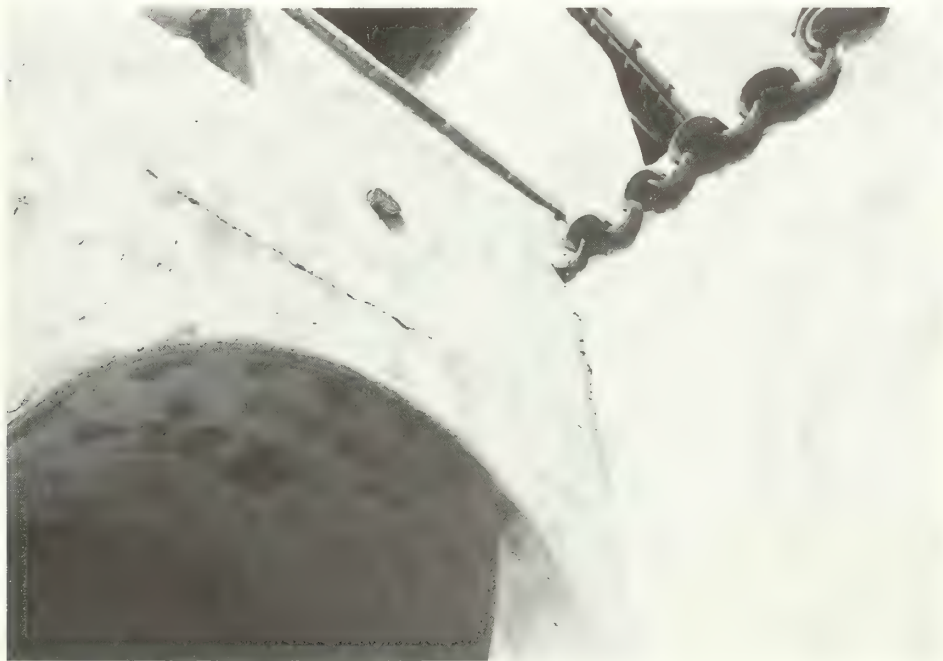
Photo 8: Southeast corner of Annex. Horizontal stucco crack above arch caused by joint in building framing. Vertical stucco crack in corner at junction with east Patio wall is predictable and a candidate for an expansion joint. (Photo by R. Silva)

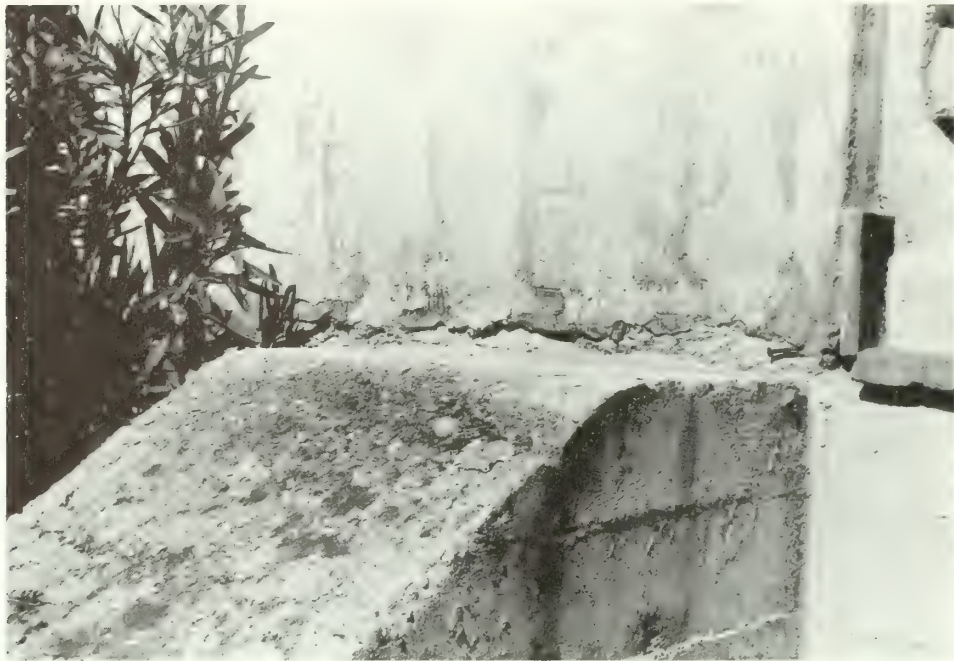
Photo 9: Concrete wall at south porch, Main House. An example of concrete work left exposed when construction stopped in 1931. Most concrete work had been intended to be finished with tile or stucco. Weathering and moisture intrusion are causing gradual deterioration. The crack at the juncture of the stucco and concrete is a typical source of water intrusion. (Photo by D. Snow.)

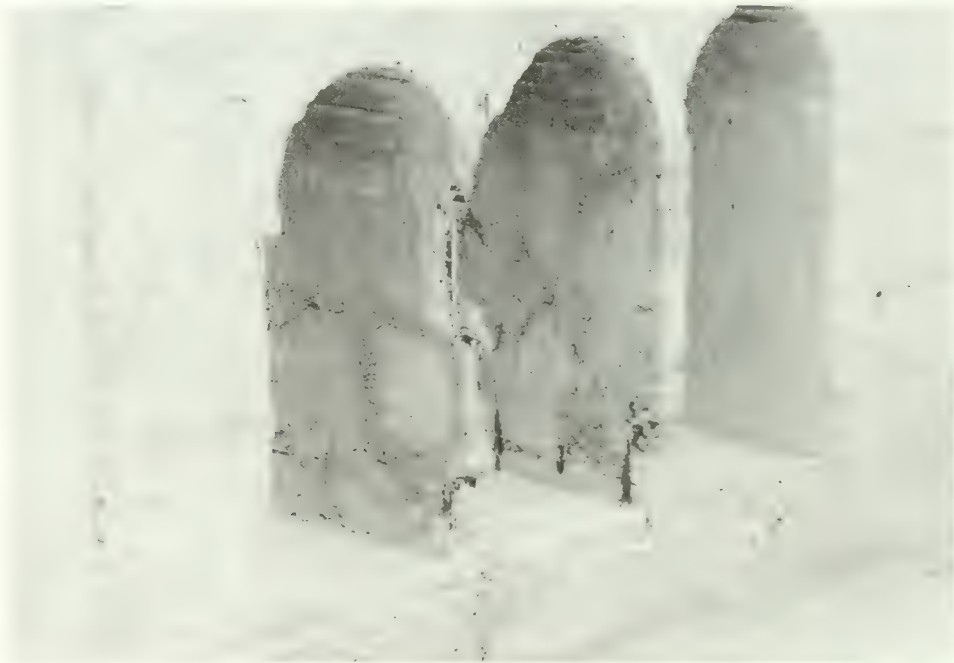
Photo 10: Advanced concrete failure and deterioration. Due to moisture causing rusting and exfoliation of steel reinforcing such as seen in this detail at the swimming pool. The lack of adequate concrete cover over reinforcing can be seen in this detail. (Photo by D. Snow.)

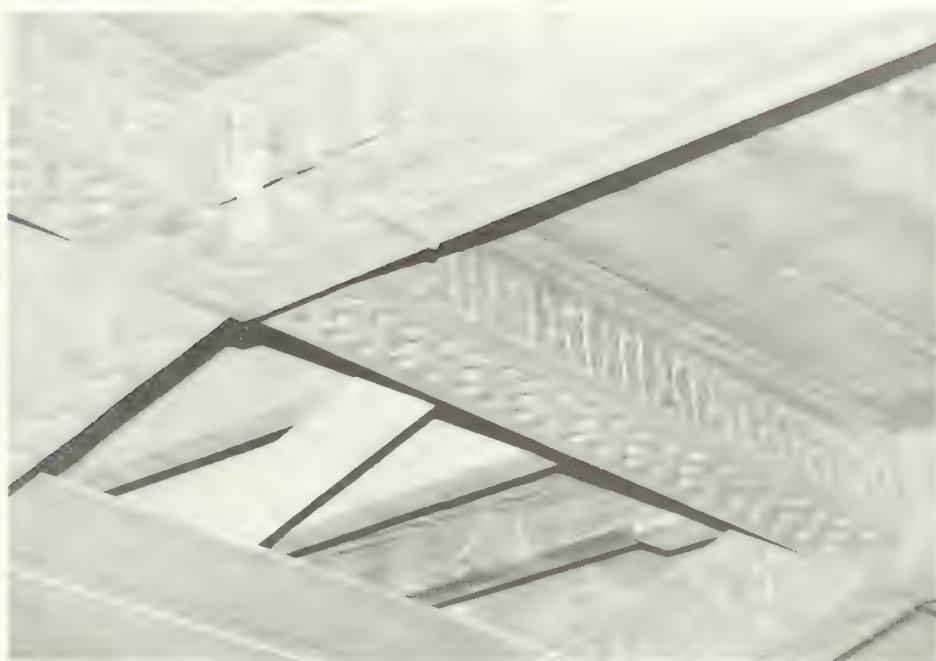
Photo 12: Detail of Dining Room decorative ceiling. Wood failure has occurred because of extreme heat and dryness. With several pieces of ceiling boarding removed, the second floor joists can be seen. (Photo by R. Silva)

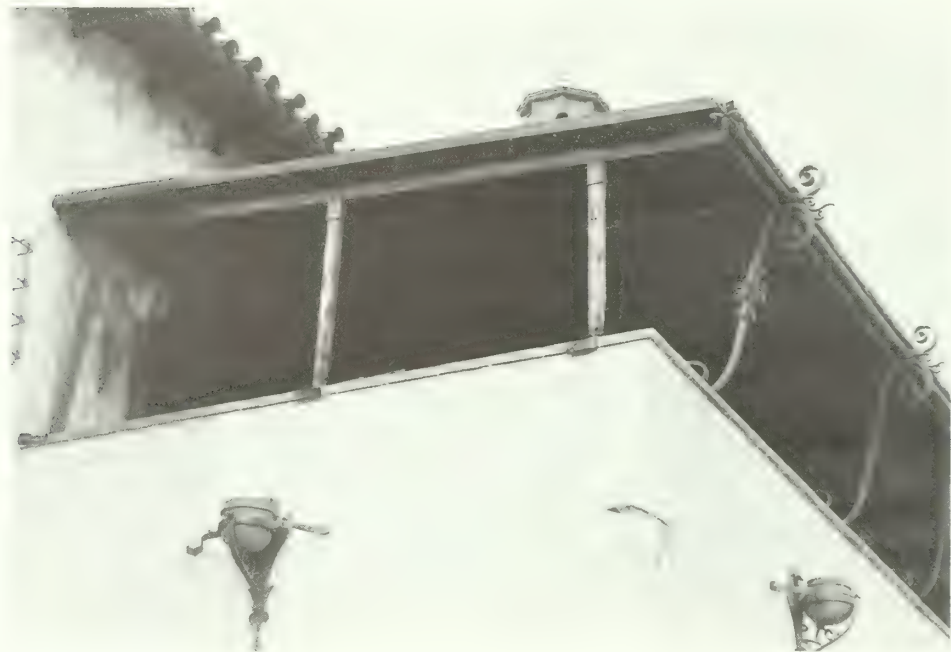
Photo 13: West end of second floor Veranda, Main House. Shows temporary supports at cantilevered end of roof. (Photo by R. Silva)

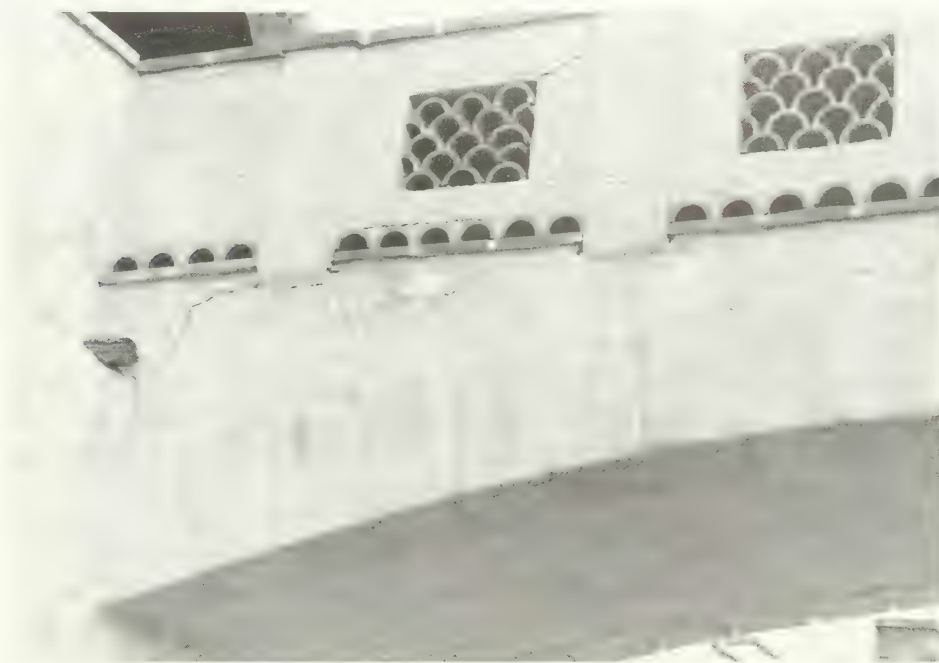
Photo 16: Stucco cracks, bridge to Annex junction. West side of bridge. (Photo by R. Silva)

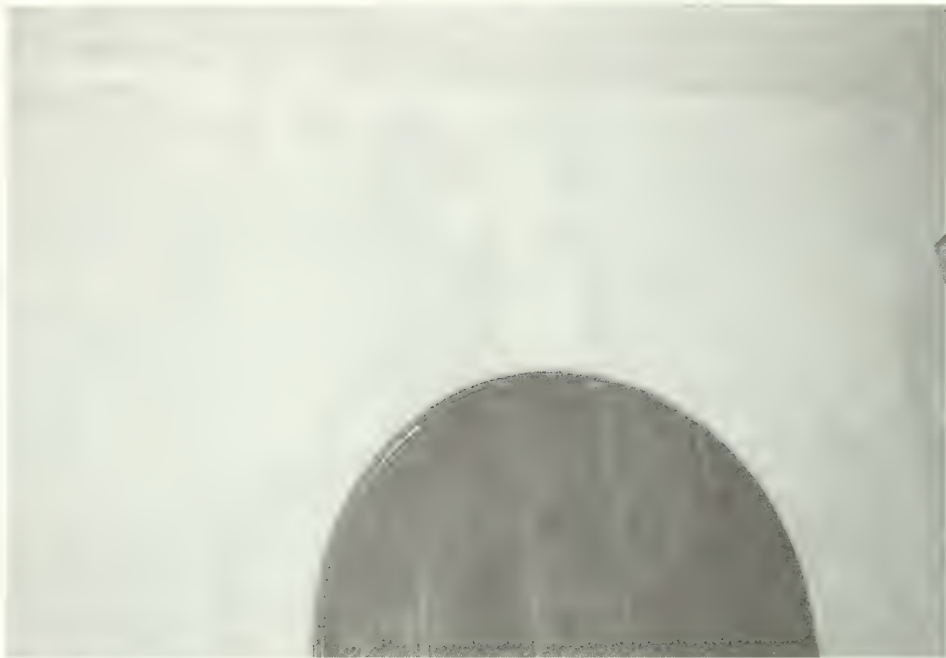
Photo 11: Annex, interior wall of Garage. Note evidence of water damage.

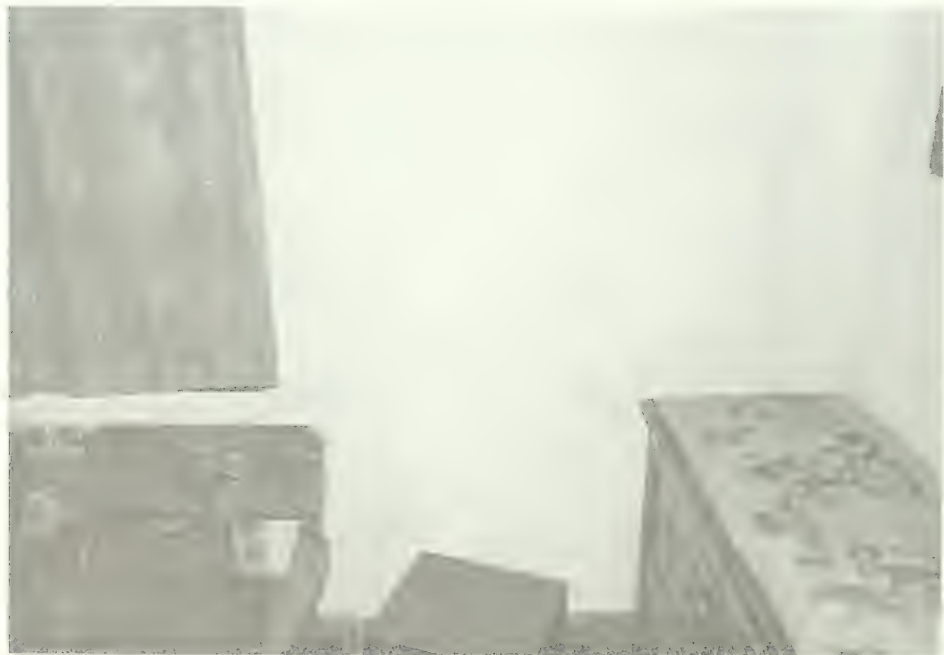
Photo 24: Annex, Upper Music Room. Note damage to plaster caused by furnishings.

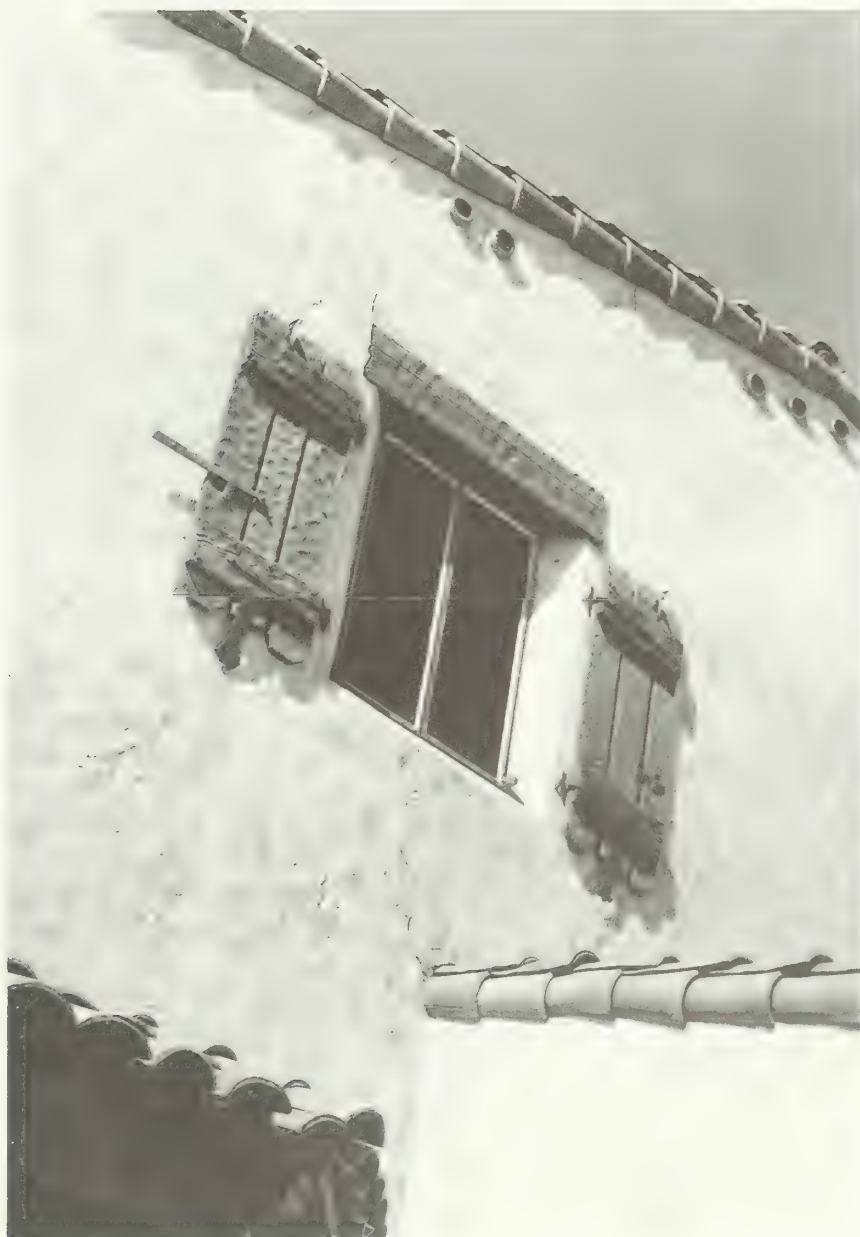
Photo 25: Main House, second floor window, southeast corner. Note crack in stucco at window sill and head.

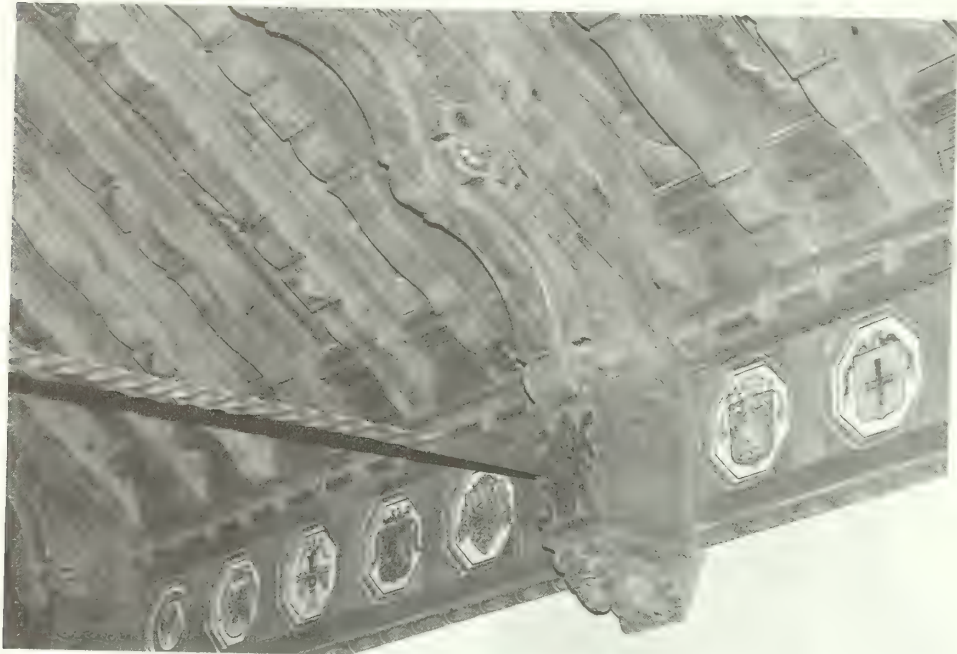
Photo 13: Ceiling detail, Upper Music Room, Annex. The wood in this room is also stained. Splitting is evident from extreme dryness. R.L. Carper, 4/90.

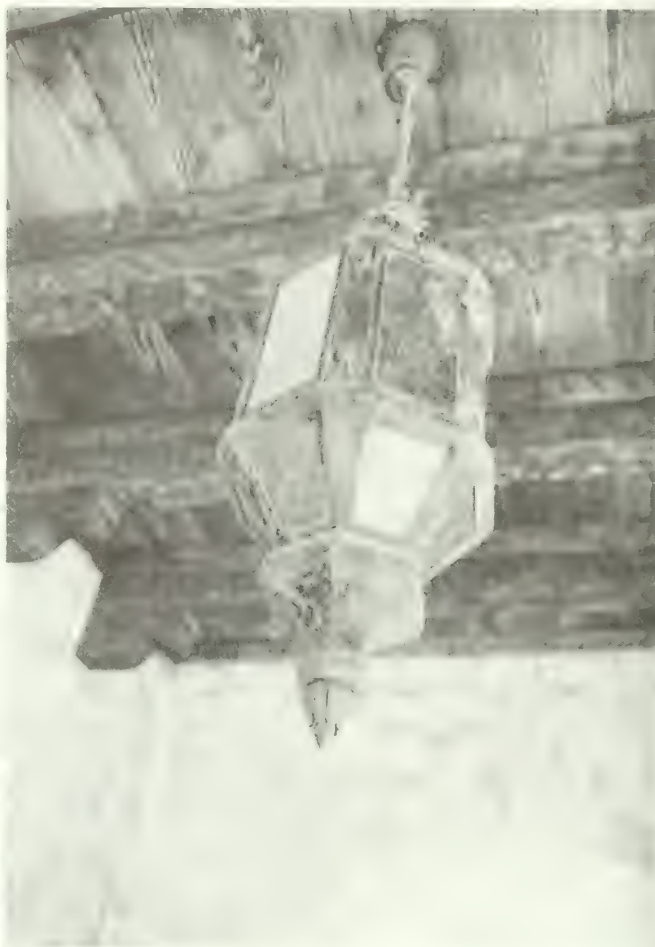
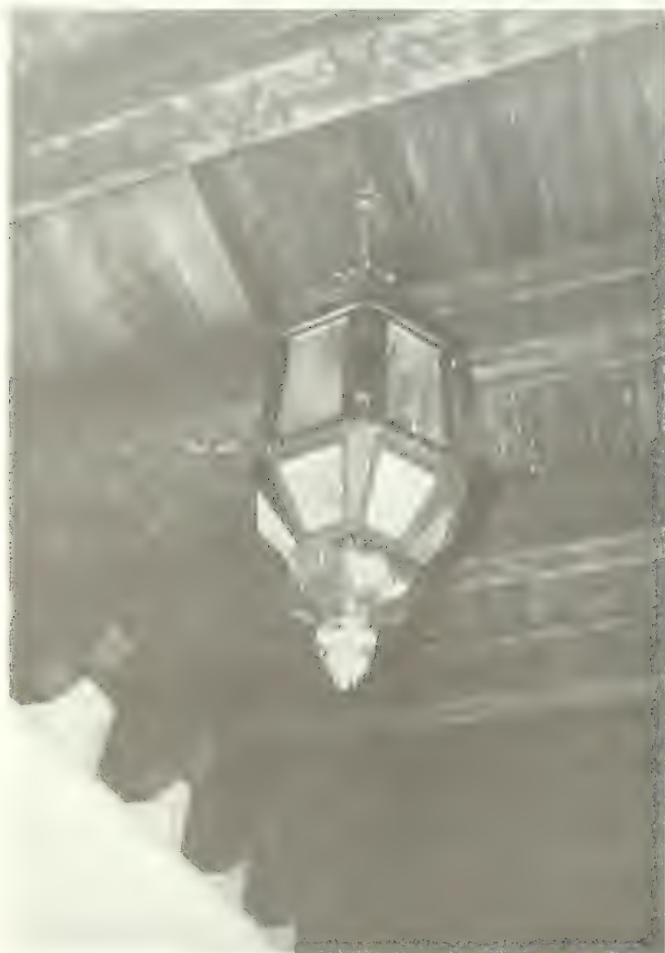
Photo 28: South porch light fixture. Companion to the one illustrated in photo 27. Note loss of "Old Iron" finish and total replacement of lantern glass.

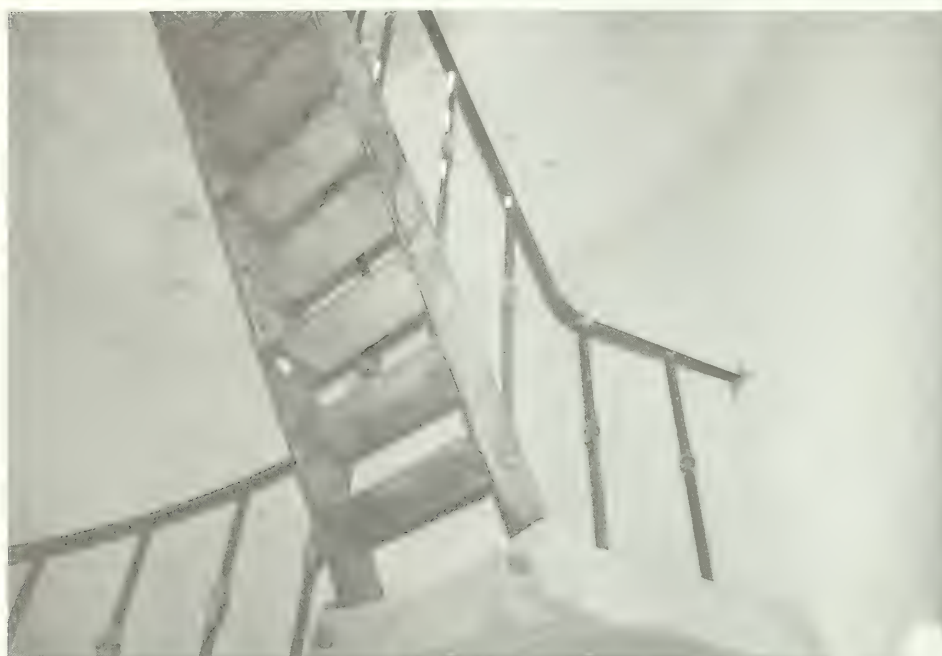
Photo 31: Stair. Leads to top of main tower at the Annex. Note actual corrosion from weather exposure on stringers and treads.

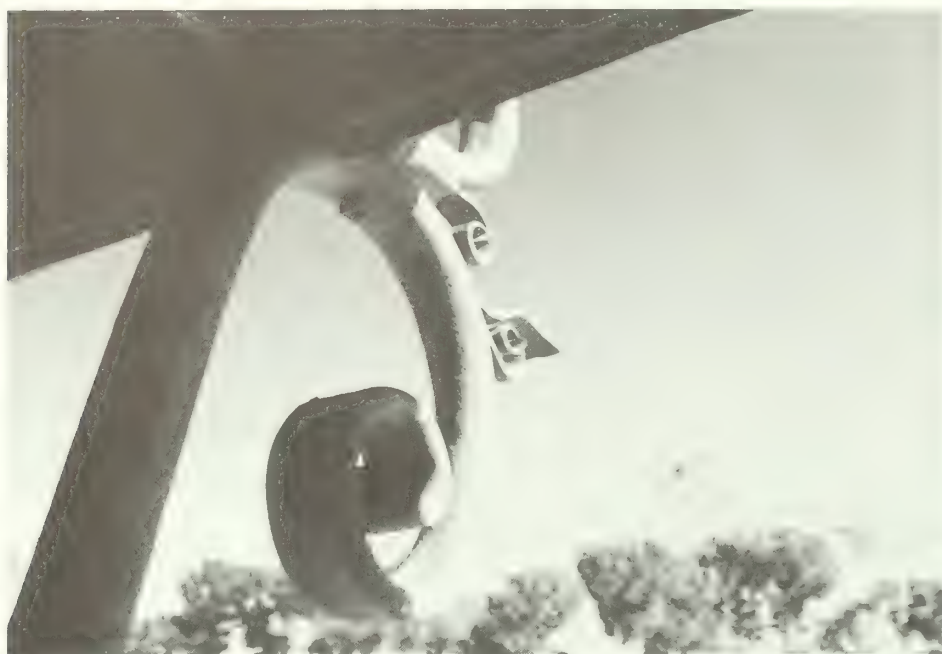
Photo 43: Decorative iron pipe support. Located on the second floor south porch of the Main House. Note the almost indistinguishable combination of actual corrosion and "Old Iron" finish.

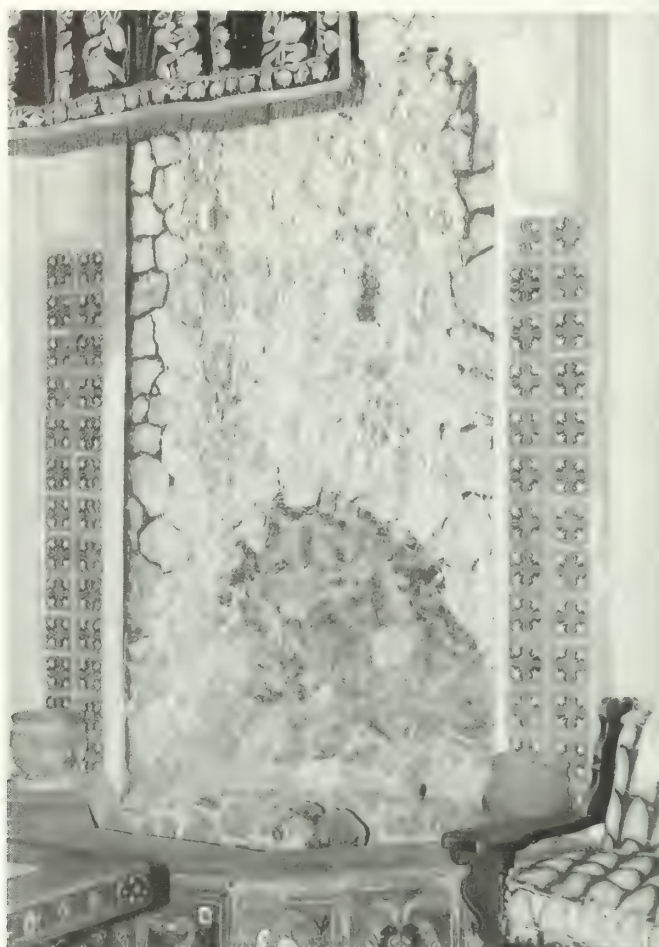
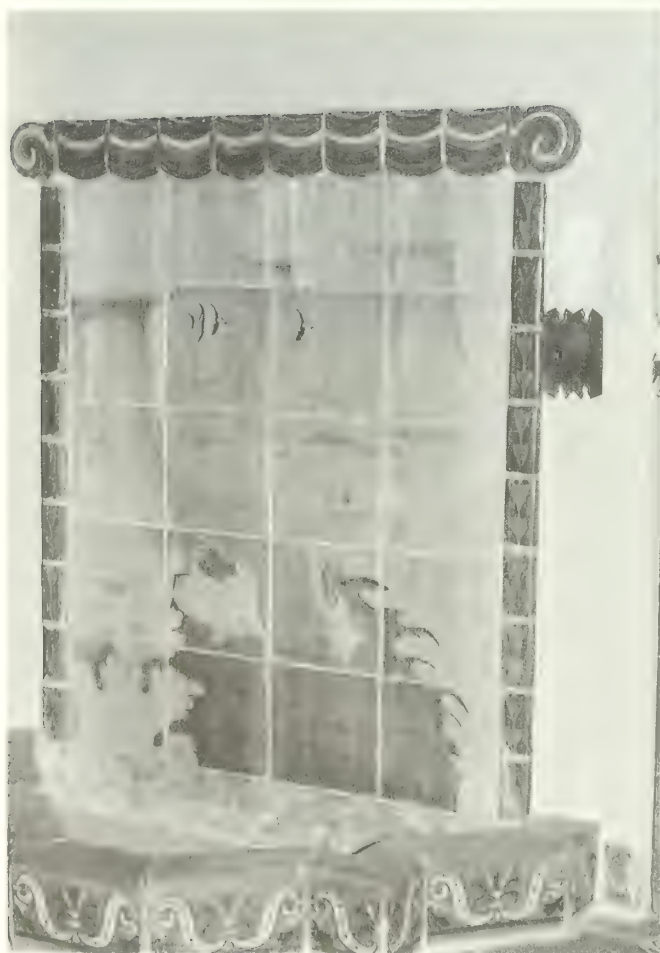
Photo 3: Solarium fountain. Tilework is reasonably sound except for mortar joints, but tile is discolored by minerals in water. Adjacent plaster is damaged from leakage. Photo by R.L. Carper, June 1990.

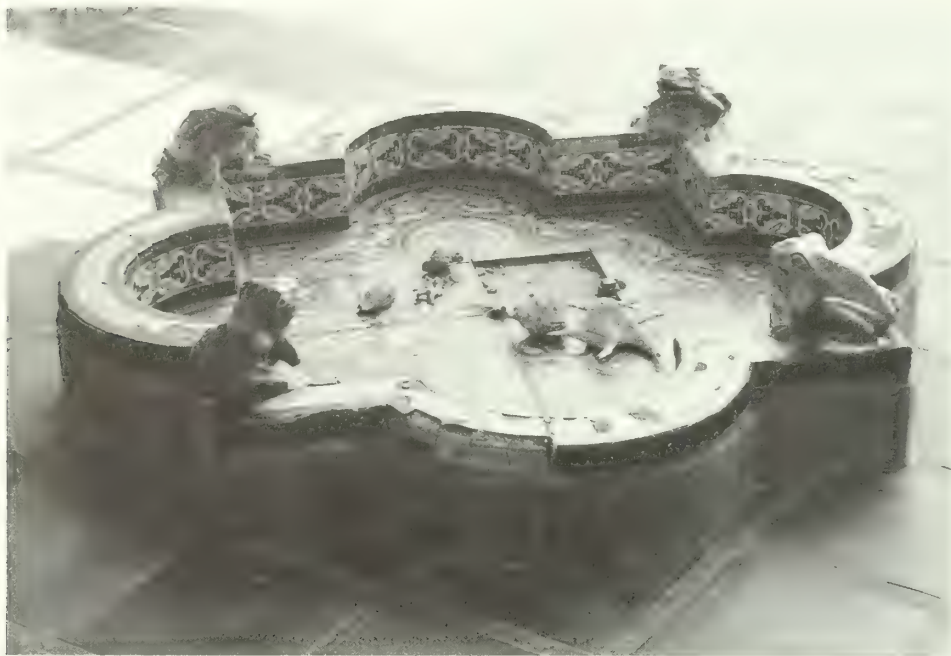
Photo 5: Lanai fountain. Tilework and plumbing is very deteriorated. Center ceramic element is in artifact collection. Photo by R.L. Carper, June 1990.

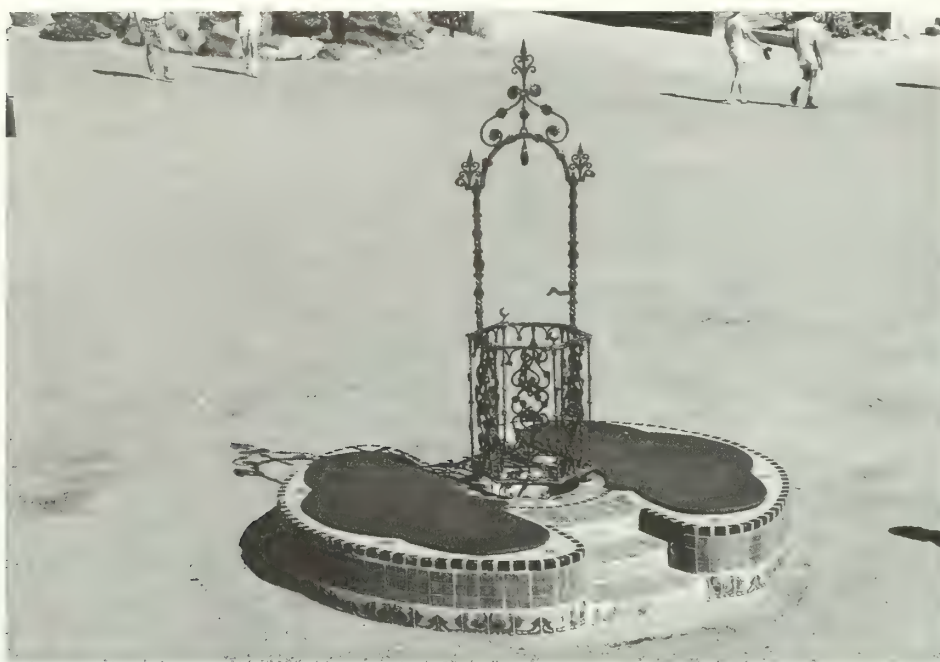
Photo 8: Entry court fountain. Not in service because of leakage and deteriorated plumbing. Photo by R.L. Carper, June 1990.

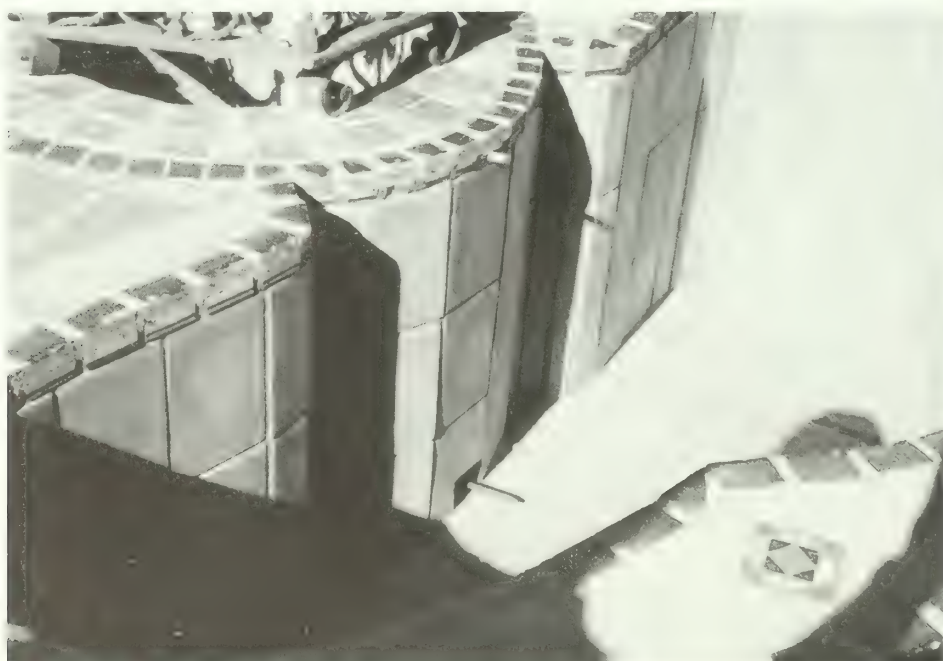
Photo 9: Detail of entry court fountain. Shows supply tube inserted through drain pipe (lower) and spray element supply pipes at top edge of basin now used as drains. Tile design is not as originally intended. Photo by P.C. Cloyd, April 1990.
